An Appraisal of Mangrove Management in Micro-tidal Estuaries and Lagoons in Sri Lanka

IUCN Sri Lanka Country Office

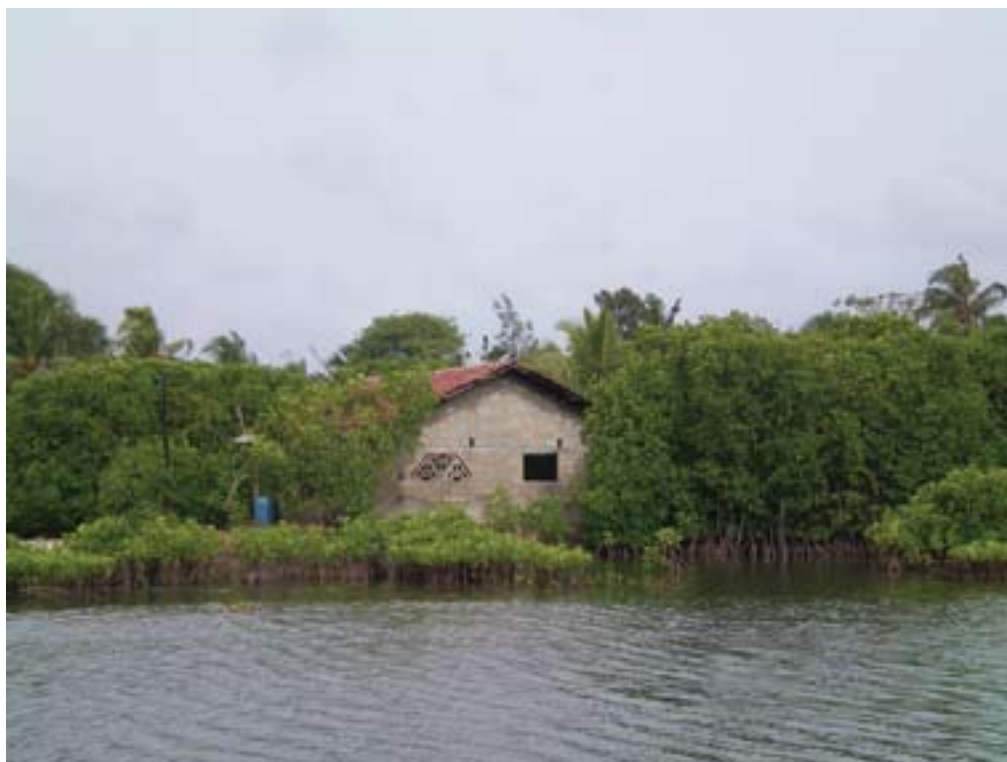
Fig. 2.1 Negombo lagoon - mangroves and constructions (Ranjith Mahindapala)

It was noted that while there is merit in planting mangroves it is necessary to examine the hydrological aspects before planting or undertaking any rehabilitation programmes to clearly understand the hydraulic dynamics of the lagoons and estuaries.

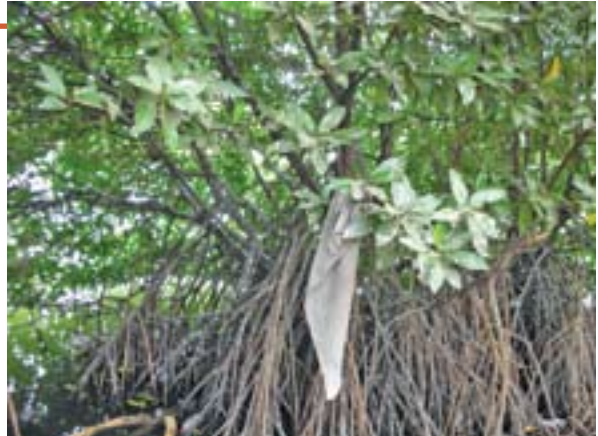
This kadol tree (*Rhizophora mucronata*) stands at the edge of the Municipal playground, Puliantivu South, Batticaloa. It is one of several planted by Mandru, an NGO in the early 1990s (Mano Rajasingam, President, Mandru, personal communication). This plant, about 10 meters in height, almost 20 years in age, has acquired adult dimensions since it was protected and maintained. Note that the well developed root

system, almost as extensive as the tree canopy, has expanded and built up a stabilized platform of sediment. This should serve as a reference, to visualize the form of the 'bioshields' planted in the post-tsunami period, in the long term. The impending loss of water surface area can be easily imagined (J I Samarakoon).

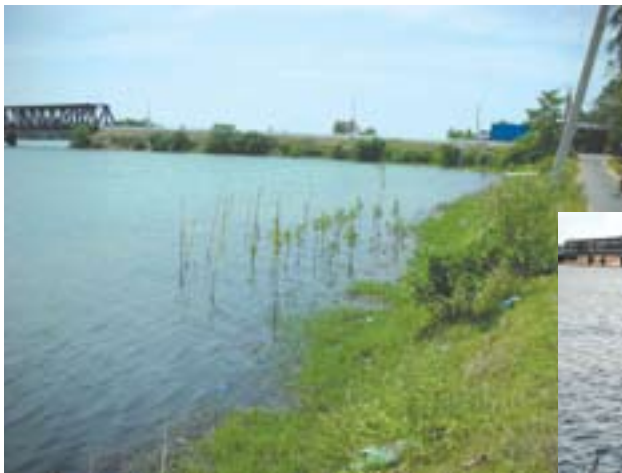
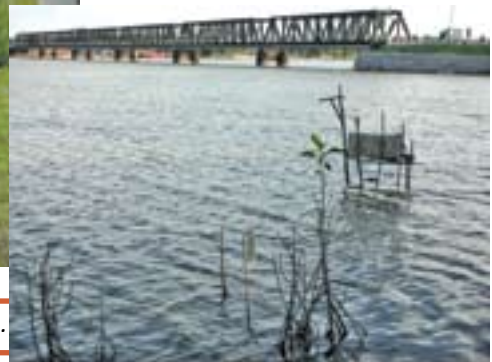
Fig. 3.2 - Form of some post-tsunami 2004 mangrove (*R. mucronata*) bioshields in Batticaloa Lagoon

Left – Photograph of a patch of mangroves soon after planting in 2007 (J I Samarakoon).

Right – Situation in 2009 (J I Samarakoon).

Evidently, survival has been poor. These mangroves were implanted as a part of a bioshield project after the 2004 tsunami. Note the position along the lagoon edge where sedimentation occurs readily. The width, length and density of trees in a vegetation belt are critical factors that determine the effectiveness of a bioshield (FAO, 2007). Perhaps these aspects were not taken into consideration at planting.

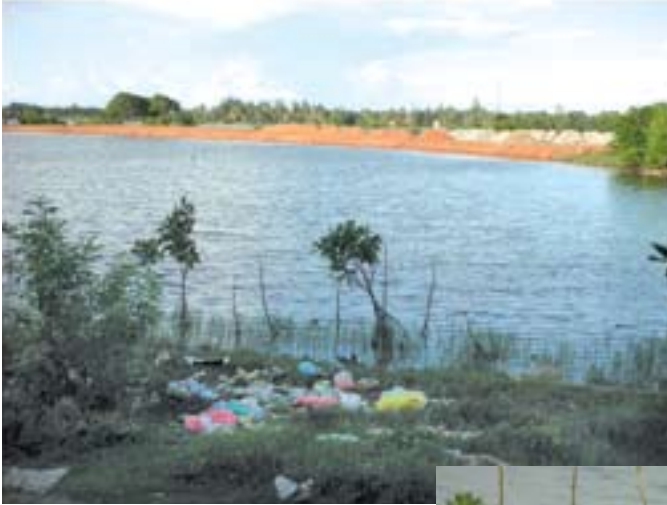
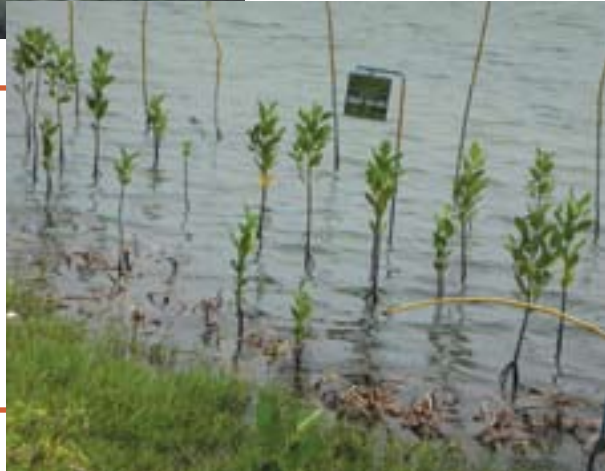
Left - mangrove seedlings planted along the lagoon edge in 2007. A few have survived with their spreading roots. The site is in a part of the lagoon where the hydrology is already impeded by a new road that transects the water. Garbage dumped at the site will add to the trapped sediment load (J I Samarakoon).

Right – photo taken in 2009. The signboard declares ‘mangrove bioshield project’. Undoubtedly, the debris being trapped among the seedlings, would eventually add to sediment deposition. With time the grass would creep into the water and create a fringe of land (J I Samarakoon).

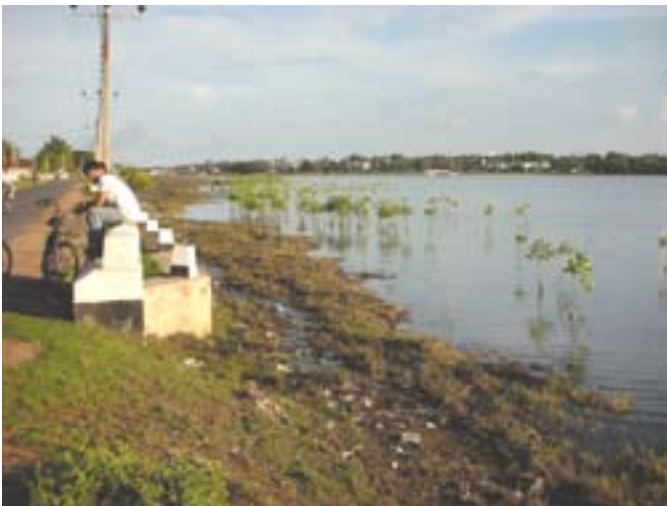
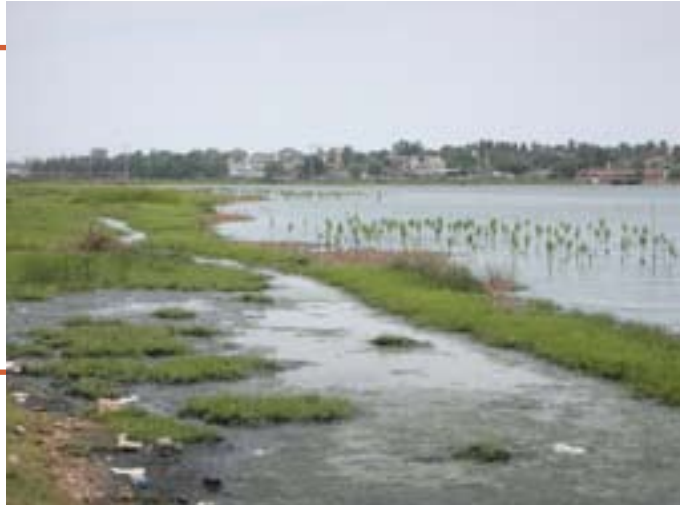
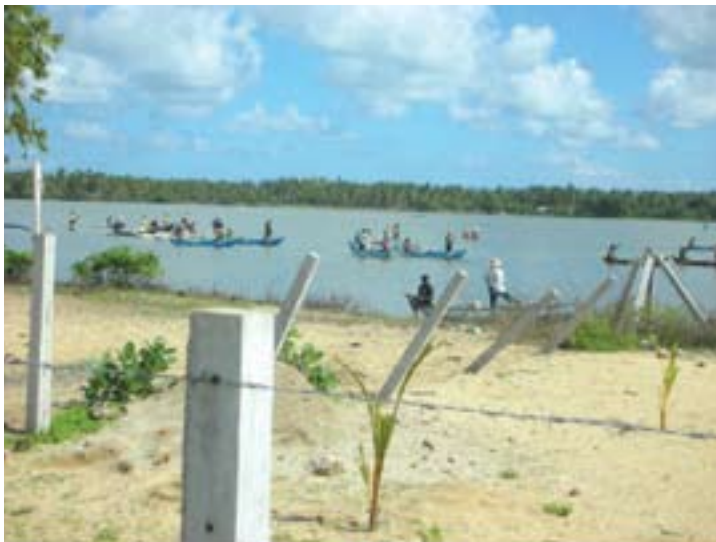
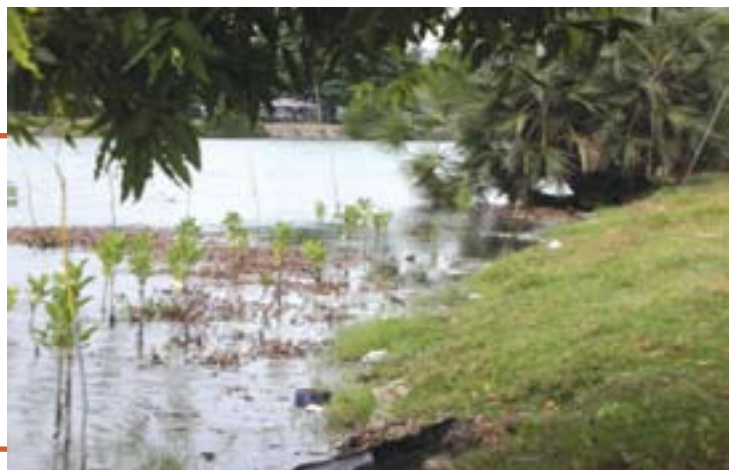
Fig. 3.3 - Mangrove bioshields: always planted at the lagoon edge where sedimentation is fastest - Batticaloa Lagoon

Photograph taken in 2009. Mangrove seedlings fronting an already sedimented strip between the road and the water spread. As the mangroves grow, more water surface will be lost (J I Samarakoon).

Photograph taken in 2007. Mangroves fronting an extensive strip of grass which has spread over and stabilized deposited sediment. Sedimentation is faster along the edges where the current speed is slower (J I Samarakoon).

Photograph taken in 2009. Traditional small scale shrimp fishing with cast nets. Some mangroves have been planted at the fringe. The seasonal upsurge in shrimp production is associated partially with abundant, submerged seagrass beds (J I Samarakoon).

Photograph taken in 2007. A patch of mangroves planted as a bioshield (note the signboard on the left). Trapping of debris is evident (J I Samarakoon).

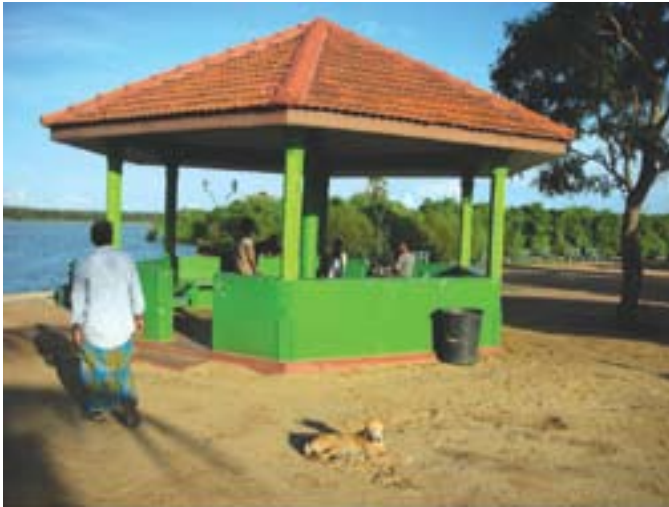
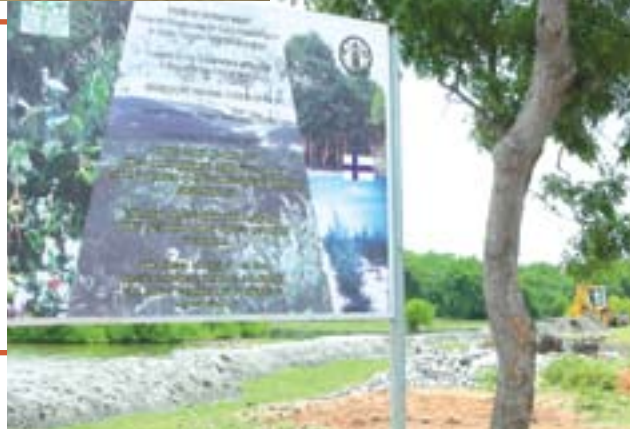
Fig. 3.4 - Unplanned mangrove rehabilitation in Batticaloa Lagoon

Batticaloa Lagoon 2009 & 2007.

The permanent structure on the left now (2009) stands on a filled part of the lagoon. Note the Neem tree on the right as a reference. The project originally intended to plant two ha of mangroves, but sedimentation is evident (J I Samarakoon).

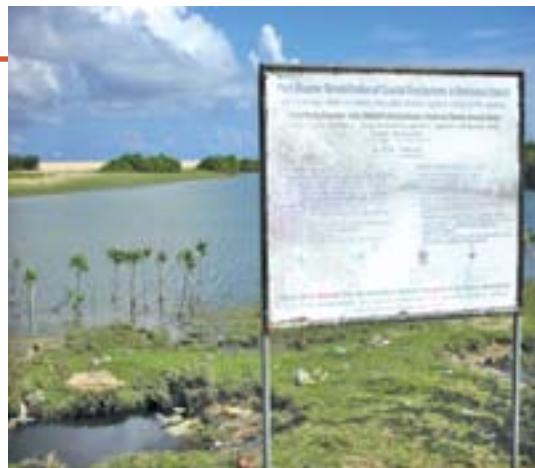
Fig. 3.5 - Mangrove seedlings planted as a component of a project to rehabilitate coastal ecosystems

Here again, the already sedimented area, stabilized by grass, remains intact while an additional strip would shortly become silted. Whether attempts such as these will result in a 'rehabilitated ecosystem' is questionable (J I Samarakoon).

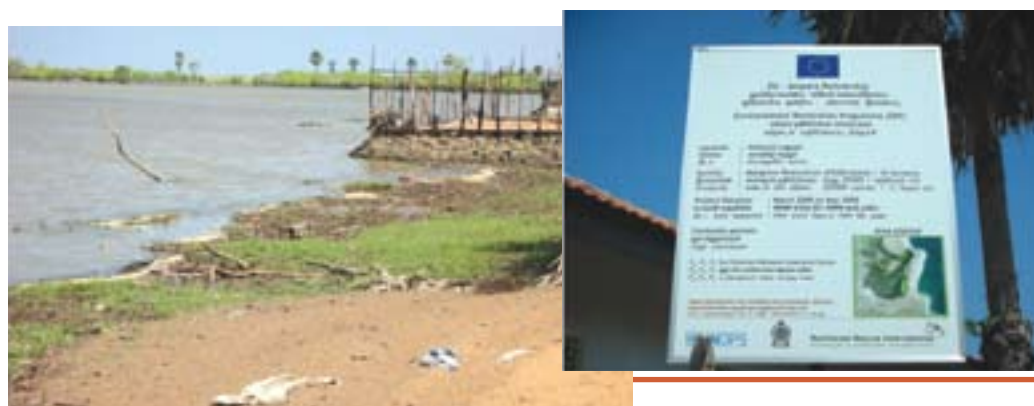
Fig. 3.6 - A poor householder capturing land in Pottuvil Lagoon

Fig. 3.6 is from a project in the Pottuvil Lagoon, a small brackish water body which supports a small scale traditional fishery. It is protected on the seaward side by a dune system. It is difficult to understand how this small lagoon, already severely silted, was selected for planting mangroves. This mangrove planting and the encroachment by a poor landless resident into an area about 25 m² (i.e. 0.02% of 12 hectares planted by the project) are equally harmful to the ecosystem.

Pottuvil Lagoon – 2009. The photo on the left shows the attempt made by a poor resident to stabilize a piece of land captured from the lagoon. A project has now pledged to plant 25,320 mangrove seedlings covering 12 ha along the fringes of this small lagoon. The long-term hydrological consequences of these two actions, encroachment by the poor local resident and mangrove planting by the project, will be no different (J I Samarakoon).

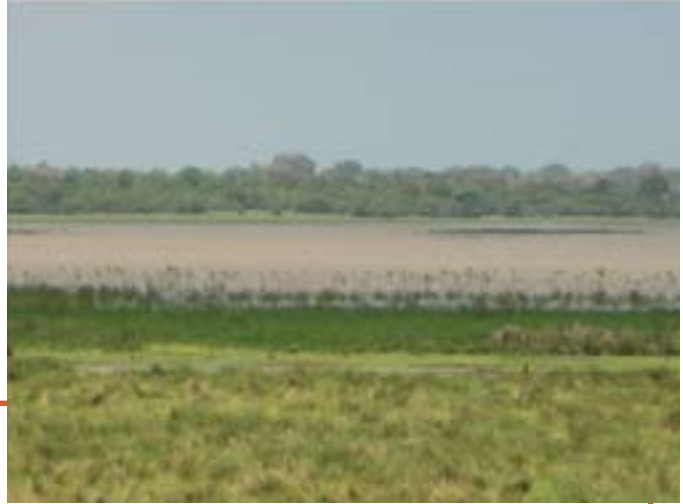
Fig. 3.7 - Mangroves planted along the eastern boundary of the Tirukkovil Lagoon

Tirukkovil 2009. Mangroves planted along the fringe of the lagoon. If the mangroves fronting the exposed land in the foreground survive and create a 'hydrological unit' that impedes drainage, it would certainly contribute to the backflow of saline water into adjoining paddy fields. If the sedimented marsh was dredged to prepare the land for mangrove planting, the hydrology and hydraulics at this location would have been enhanced and thereby expanded the surface water spread (J I Samarakoon).

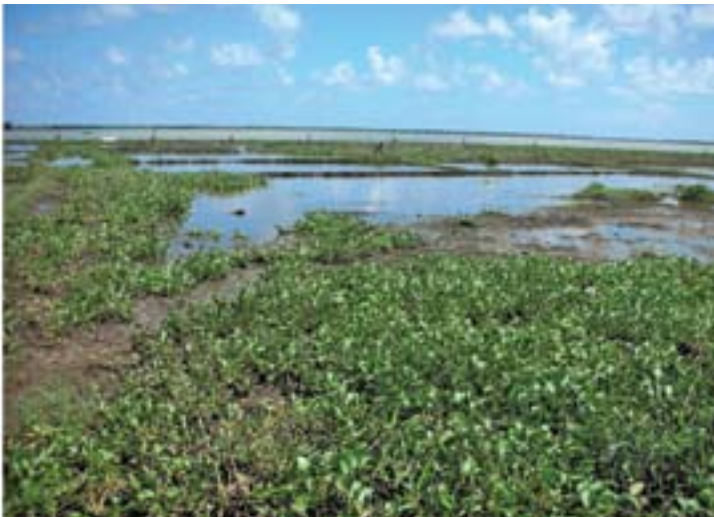
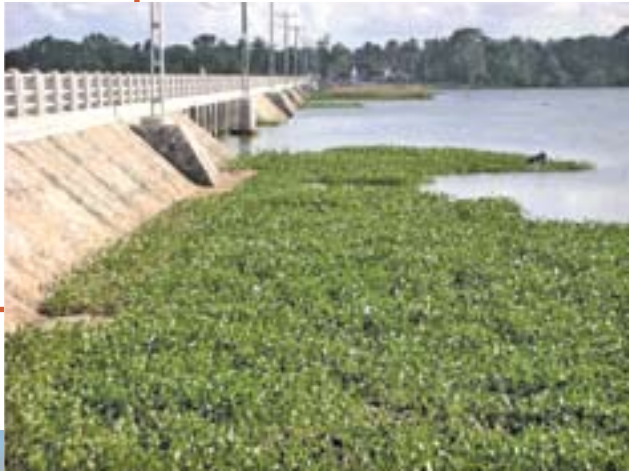
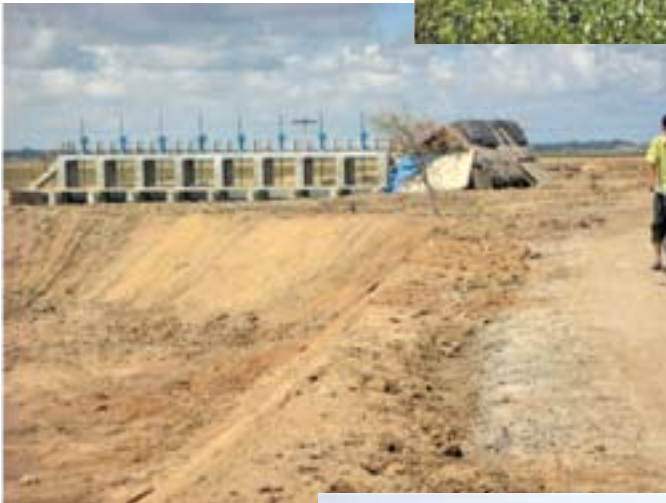
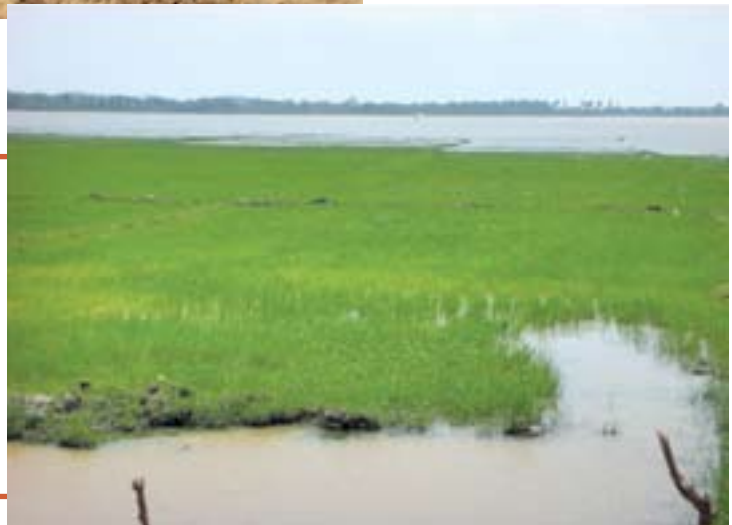
Batticaloa Lagoon 2010, Vavunativu: New paddy fields being constructed encroaching on sections of the lagoon included within the existing surface spread (J I Samarakoon).

*Batticaloa Lagoon 2010,
Koddaikallar: completed
bridge which demonstrates its
efficiency in the obstruction of
hydraulics resulting eventually
in increased sedimentation. A
significant hydrological unit!
(J I Samarakoon).*

*Batticaloa Lagoon, 2010,
Kokkadicholai. Shrimp
ponds with water control
structures which influence
hydrology and hydraulics
(J I Samarakoon).*

*Batticaloa Lagoon 2010,
Some paddy fields at
Mandoor bordering the
lagoon. These influence
hydraulics, while
imposing a need for
maintaining freshwater
conditions
(J I Samarakoon).*

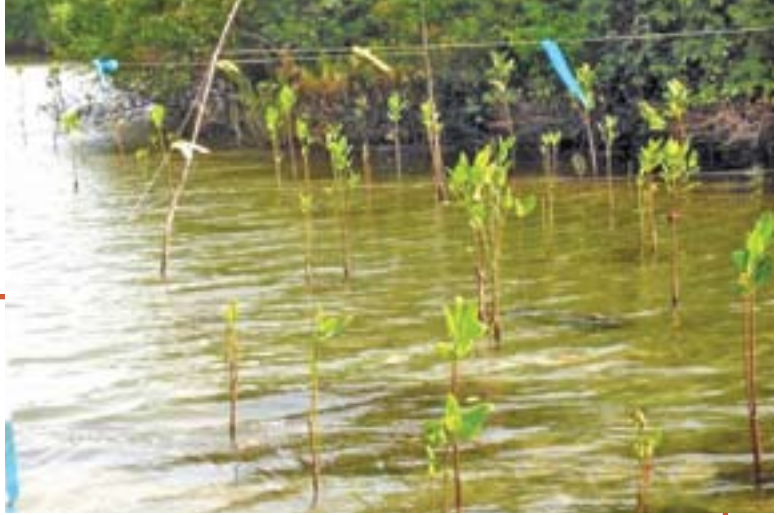
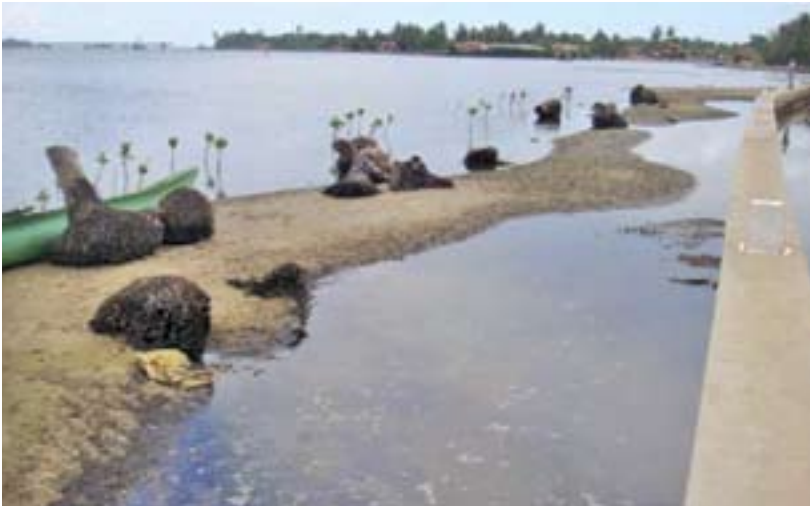
Fig. 3.9 - Mangrove planting at some locations in the Eastern Province (other than Batticaloa Lagoon).

Location unknown. This mangrove planting shares common features with the other photos - the planting fronts existing mangroves, evidently without any form of land preparation or consideration given to water flow, fish habitat or hydrology (T Jayasingam).

Kinnya, Trincomalee: 2009. Mangrove seedlings have been planted fronting an eroded strip of coast which evidently was stable in the past. The coconut stumps suggest that coconut palms were grown along this strip of land. The concrete wall on the right is evidently a protective structure constructed after the 2004 tsunami to protect the road infrastructure seen further to the right. Perhaps, the mangrove seedlings were planted as a part of a bioshield project or specifically to protect against erosion. It would be necessary to verify the dimensions and layout of the initially planned intervention (T Jayasingam).

Similar situations are evident from other locations in the Eastern Province (Figs. 3.9).

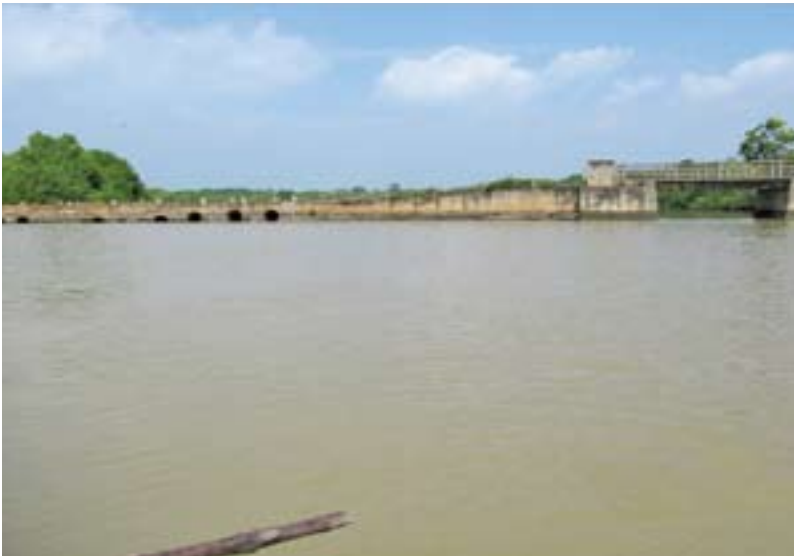
Fig. 3.11 - Rekawa Lagoon - Kapuhenwala bridge, a significant 'hydrological unit', which impedes hydrology and hydraulics in Rekawa Lagoon. Mangrove planting requires integration with its impacts on sediment movement.

The Kapuhenwala Bridge has been implicated in diminishing fishery in Rekawa Lagoon. The bridge obstructs recruitment of early stages of fish and shrimp into the body of the lagoon when the connection to the sea opens during the rainy season. Diverse interventions have been implemented to improve the hydrology and fishery but lasting impacts are missing. Serious socio-political analysis, based on costs and benefits, is essential at the planning stage, to avoid such blunders (S Epitawatte).

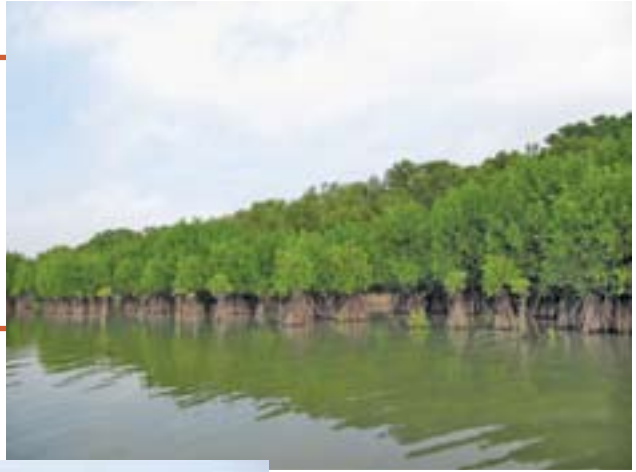
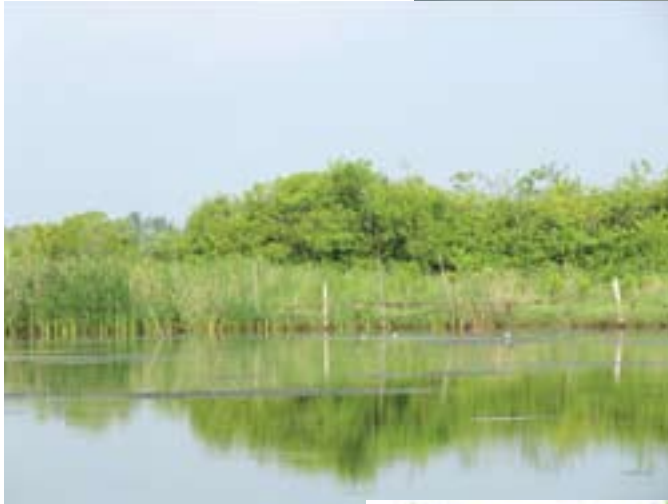
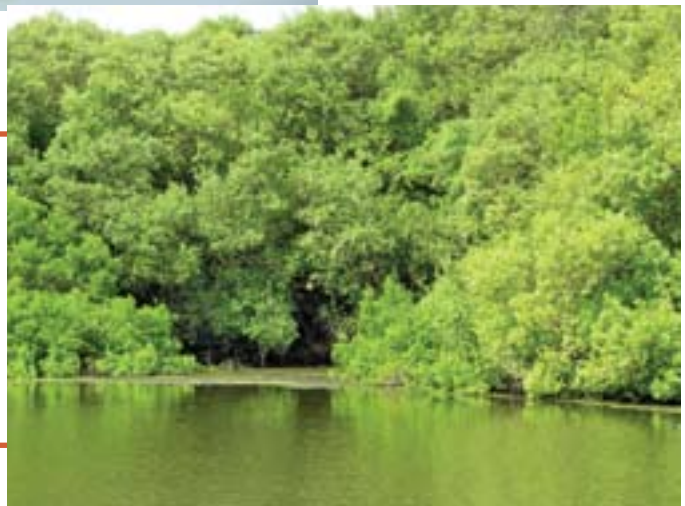
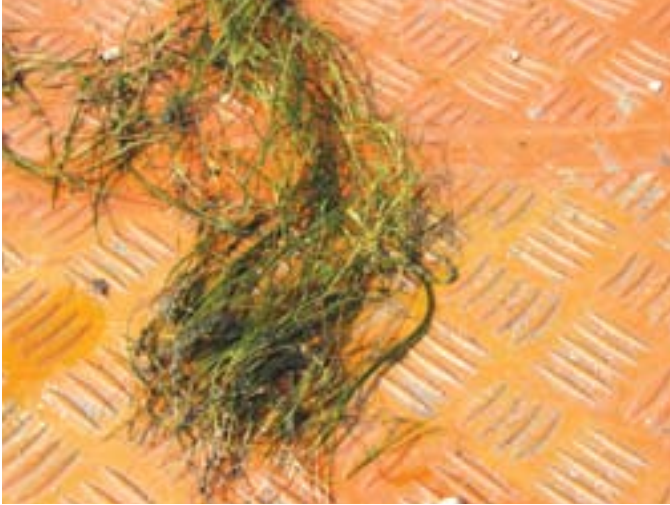
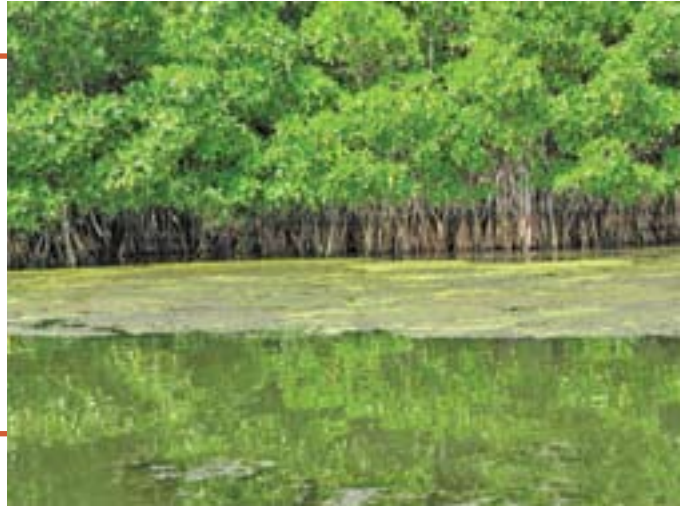
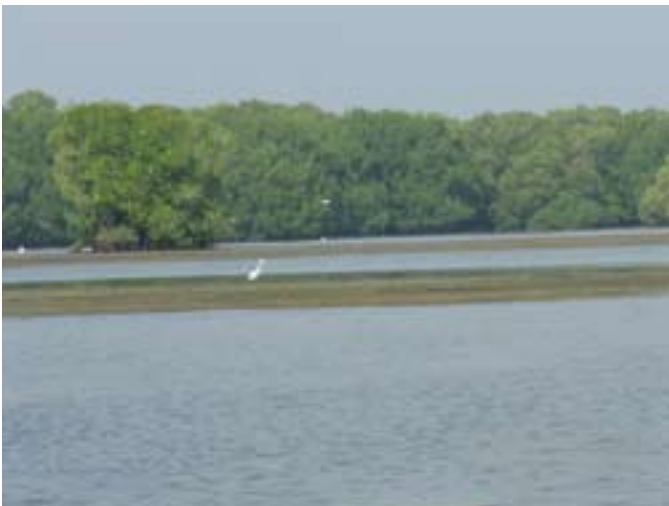
Rekawa Lagoon, 2010. Row of mangroves planted since the tsunami 2004. The row fronts another species of mangroves (Avicennia sp.) which has already formed a land platform (S Epitawatte).

Rekawa Lagoon 2010. At some locations reed beds front mangroves (Avicennia sp.) and contribute to sediment build-up in the low salinity environment. Tidal exchange is cut off most of the year (S Epitawatte).

Luxuriant, stand of mangroves species, suggestive of excellent soil conditions. Filamentous algal blooms indicate availability of nitrates. Sedimentation is evident (S Epitawatte).

*Rekawa Lagoon 2010. Seagrasses (probably *Halodule* sp.) grows submerged as extensive meadows. Seagrasses synergistically stabilize sediment with mangroves (S Epitawatte).*

Rekawa Lagoon 2010. Extensive patches of partially decayed filamentous green algae, a good indicator of eutrophication in brackish water bodies. Decaying algae eventually add to organic deposits (S Epitawatte).

*Rekawa Lagoon 2010. An extensive sediment shoal (note the egret). A clump of mangrove (*R. mucronata*) stands sentinel over the neighbouring sediment shoal. What is the destiny of these stabilized shoals? (S Epitawatte).*

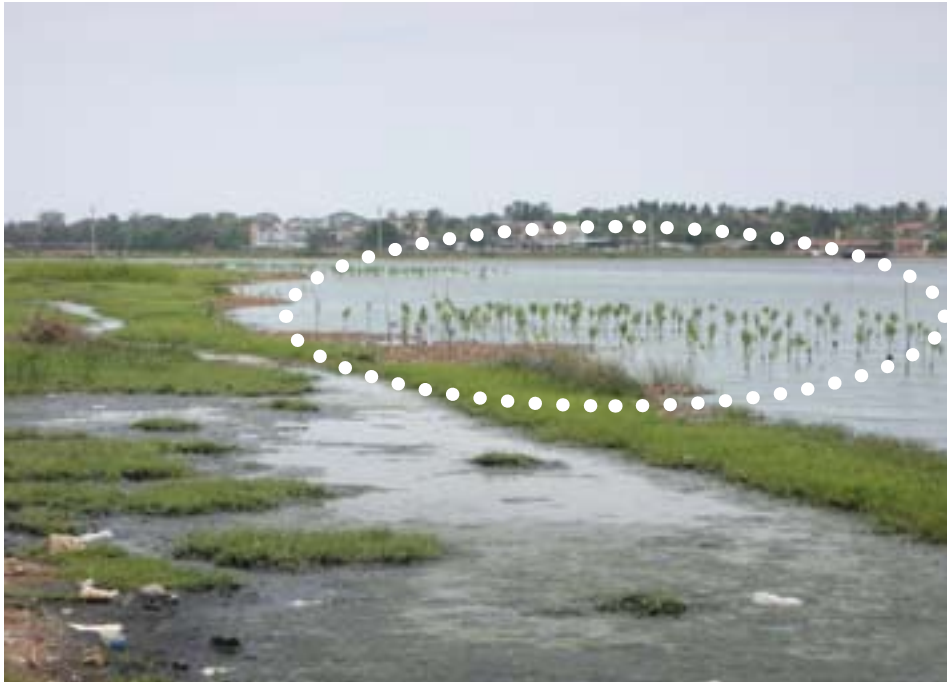
Fig. 4.1 - Mangrove seedlings planted in Batticaloa Lagoon at a site where mangroves were not known to exist for many decades

Mangrove seedling implantation in sites that did not host mangroves before is quite typical of mangrove 'restoration', mangrove rehabilitation, ecosystem restoration and 'bioshield' establishment projects in Sri Lanka's barrier-built estuaries and lagoons. These cannot be considered as restoration projects as the sites were devoid of mangroves before (J I Samarakoon).

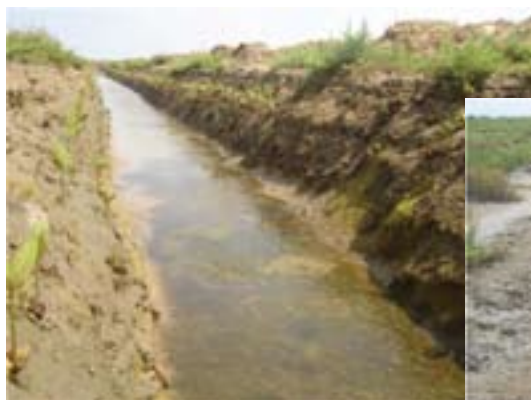
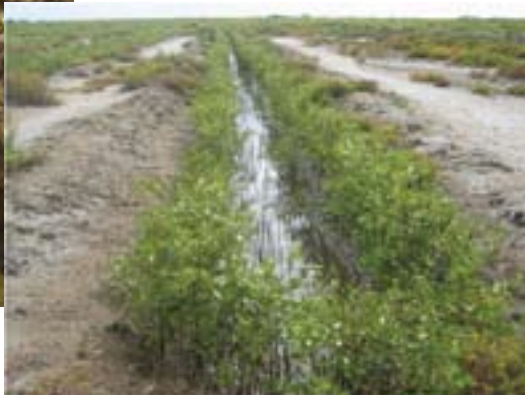
Box 4.1. Recommended technique for mangrove restoration in low tidal amplitude areas

Low tidal amplitude areas such as Tamil Nadu and Andhra Pradesh have developed a planting technique called “Canal Bank Planting” for restoration of mangroves. The ‘Fish bone’ design is the latest and most successful design for canal bank planting. This technique involves the construction of the feeder canal (3 m top width x 1 m bottom width x 1 m depth) and distribution canals (2 m x 0.75 m x 0.75 m) in the mud flats, and planting propagules directly in the inter-tidal zone of the canal banks. Biodiversity enrichment, however, is left to nature, and nature does it very efficiently. In a nutshell, wherever tidal amplitude is low, the canal bank planting technique using the fish bone design is the preferred system for restoration (J I Samarakoon).

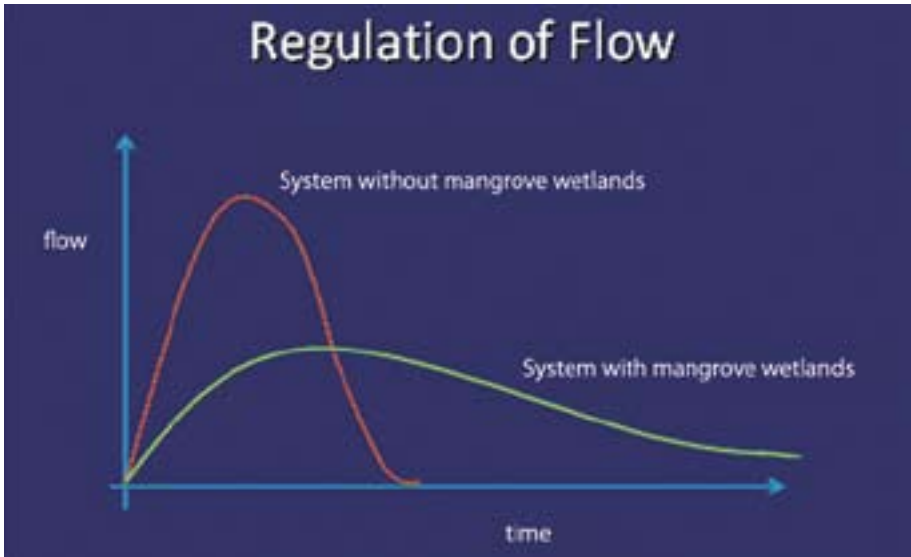
As depicted by the following graph mangroves play a major role in regulating the water flow.

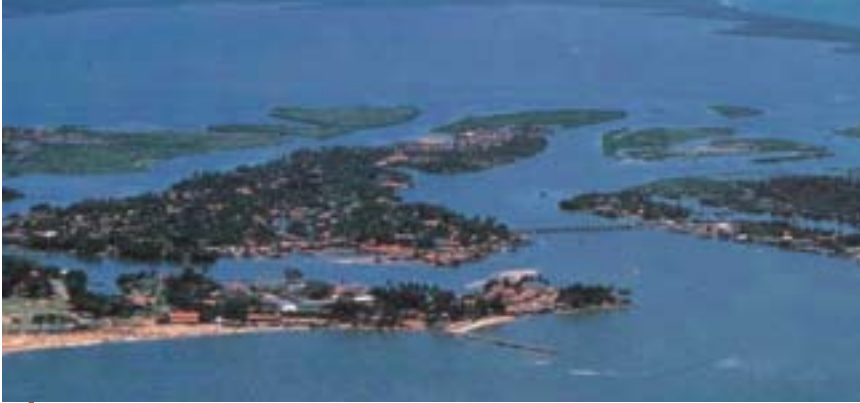
The view looking south into a placid lagoon belies the hydrological reality (1989). The mouth is stabilised by engineering. The set of three geographic information system images below show the state of sediment infilling (cyan – pale blue) in a period of 15 years.
